# **A Poster-Child for Tank Abuse**

**And the Herculean Effort to save it  
from a Wrecker's Hammer**

# A 2,500,000-gallon GST

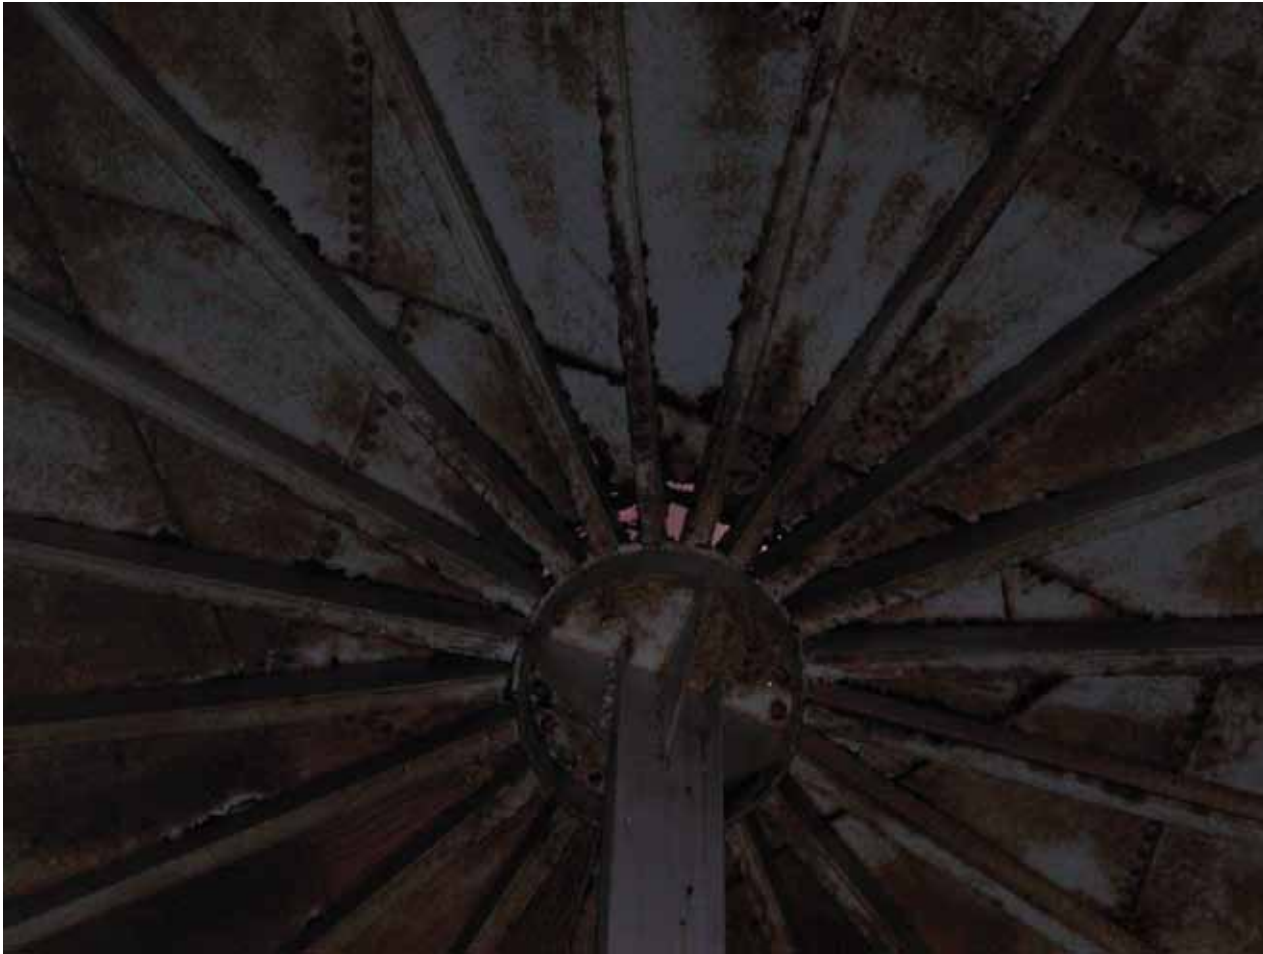
# Roof plates and support members

**We put a new steel roof and support steel on it**

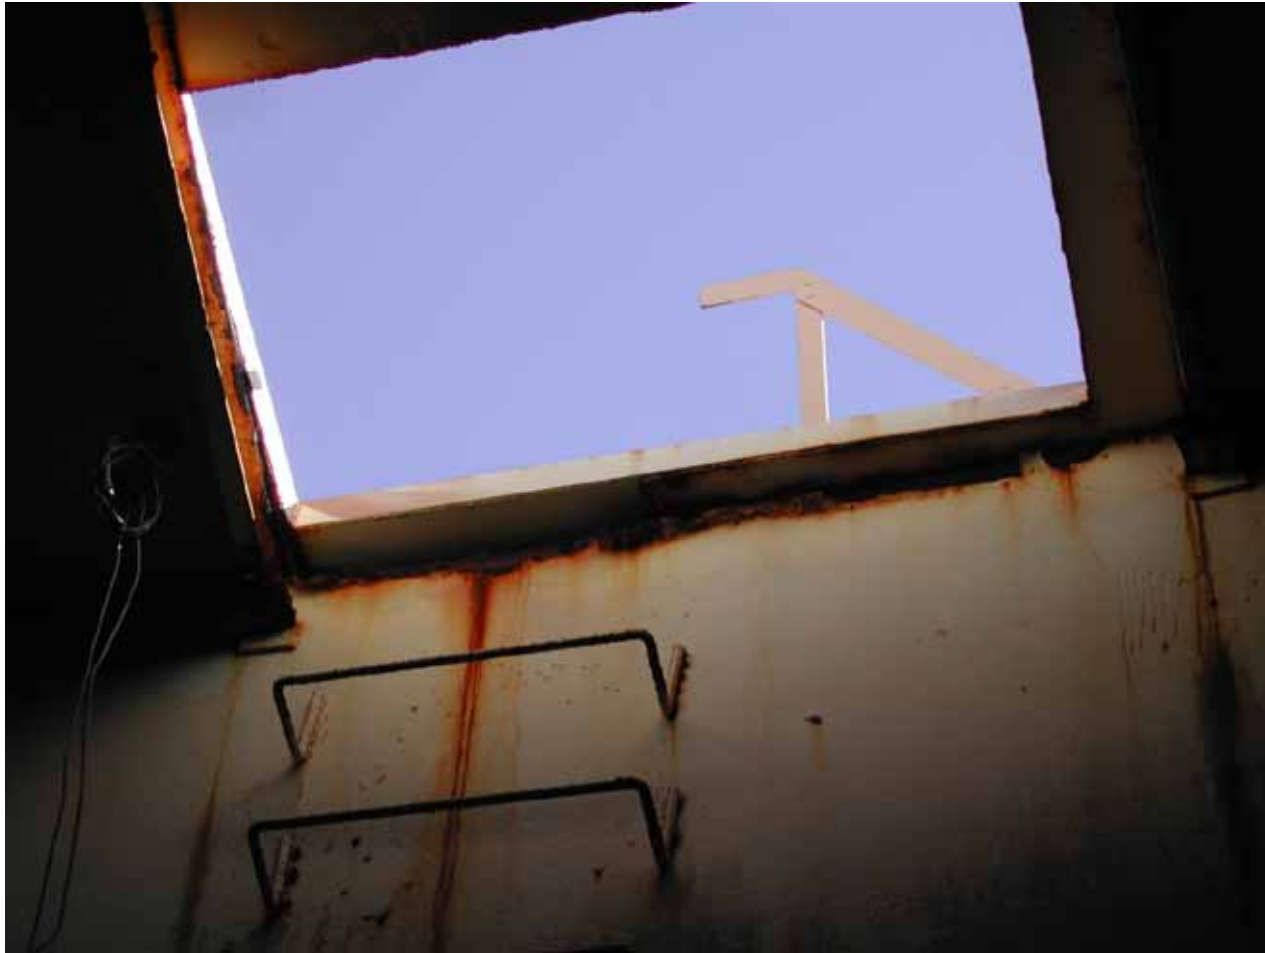
# Corroded out roof Hatch

# We added 2 new roof hatches & OSHA Approved Handrails

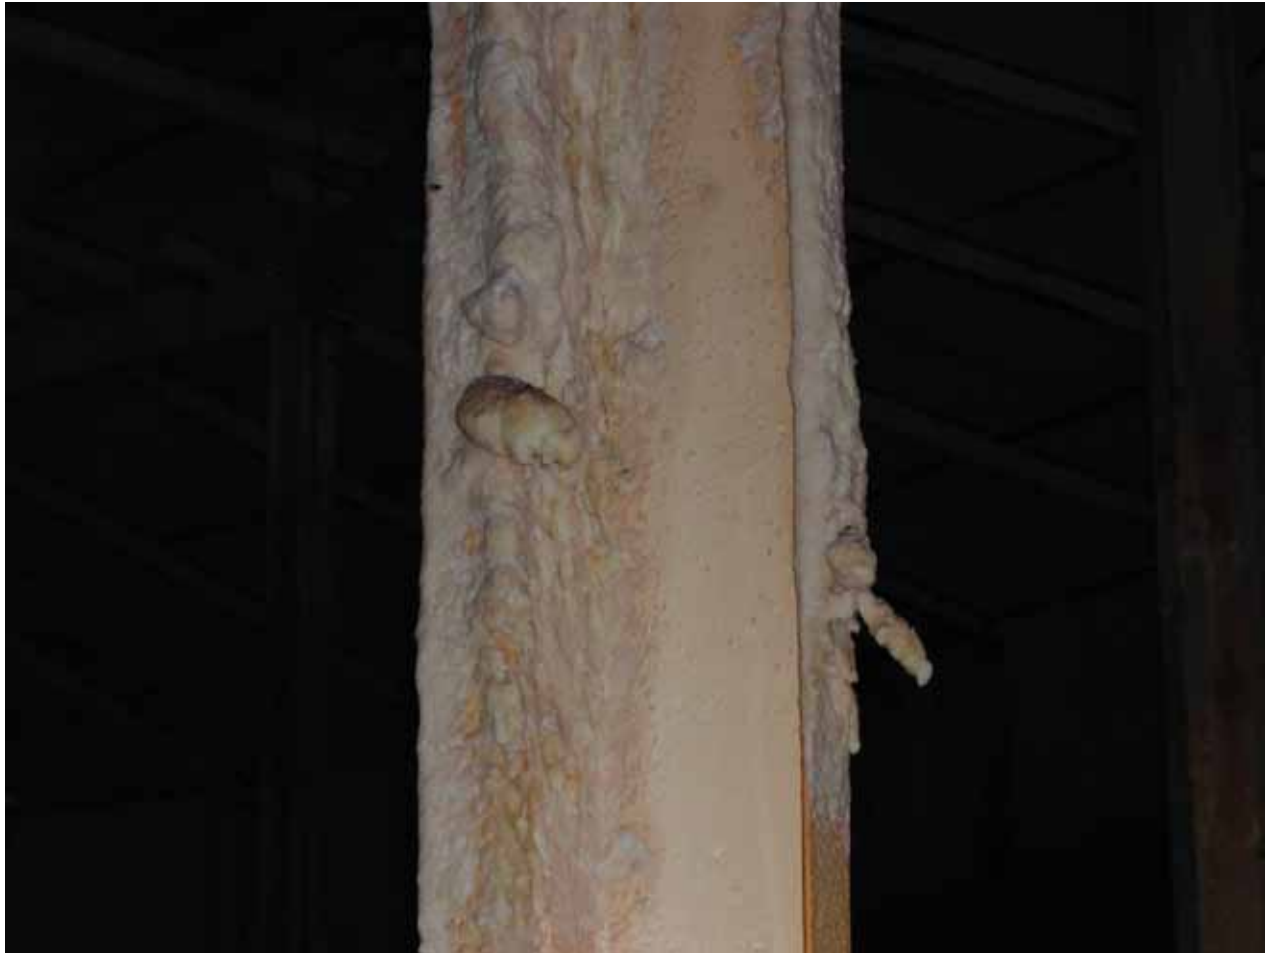
**Been a while since it was cleaned!**

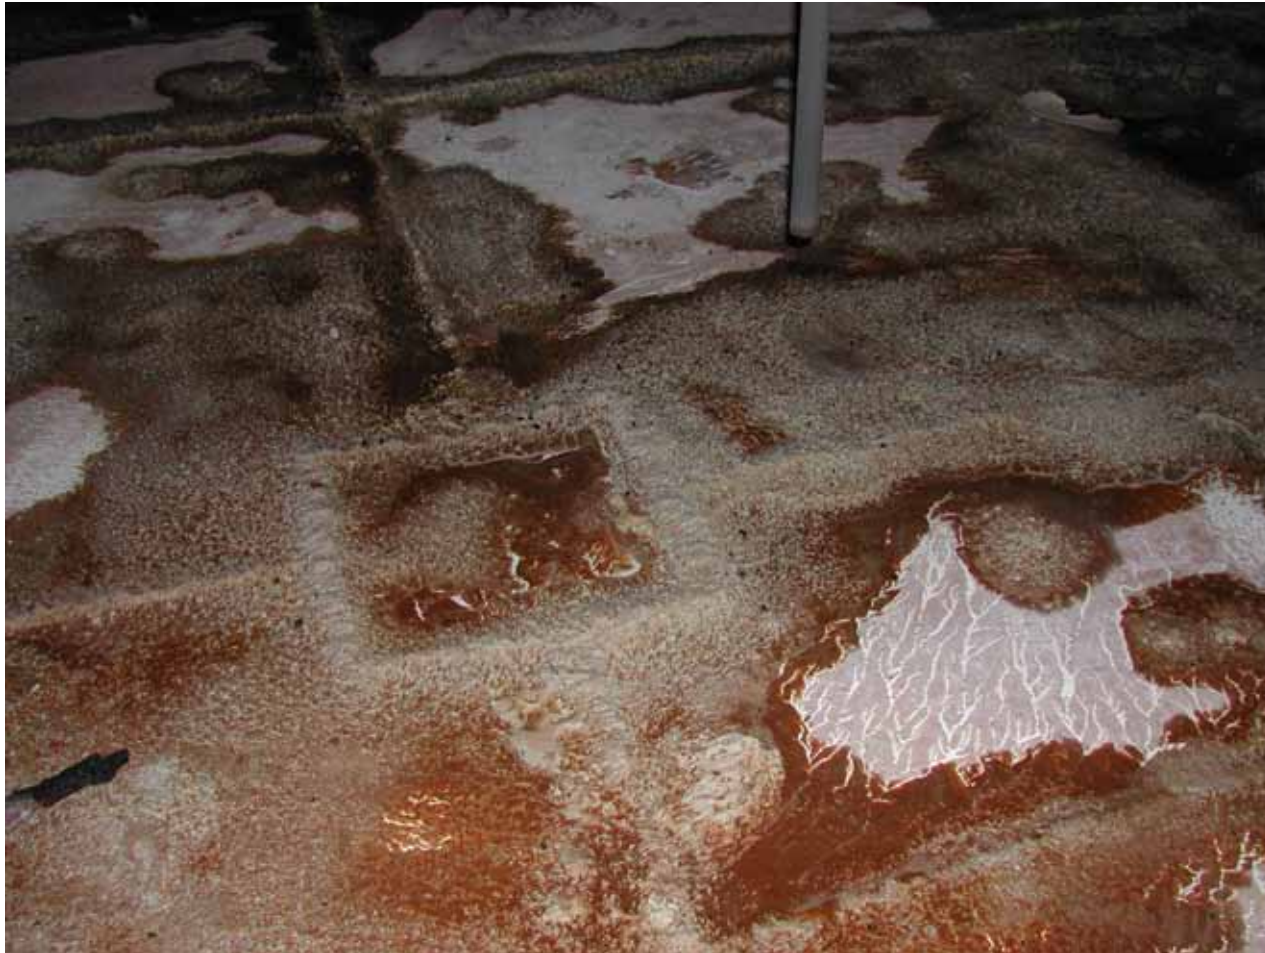
# Floor was a leaking disaster

**A synthetic floor was applied to the old to bolster it and keep leaks away**

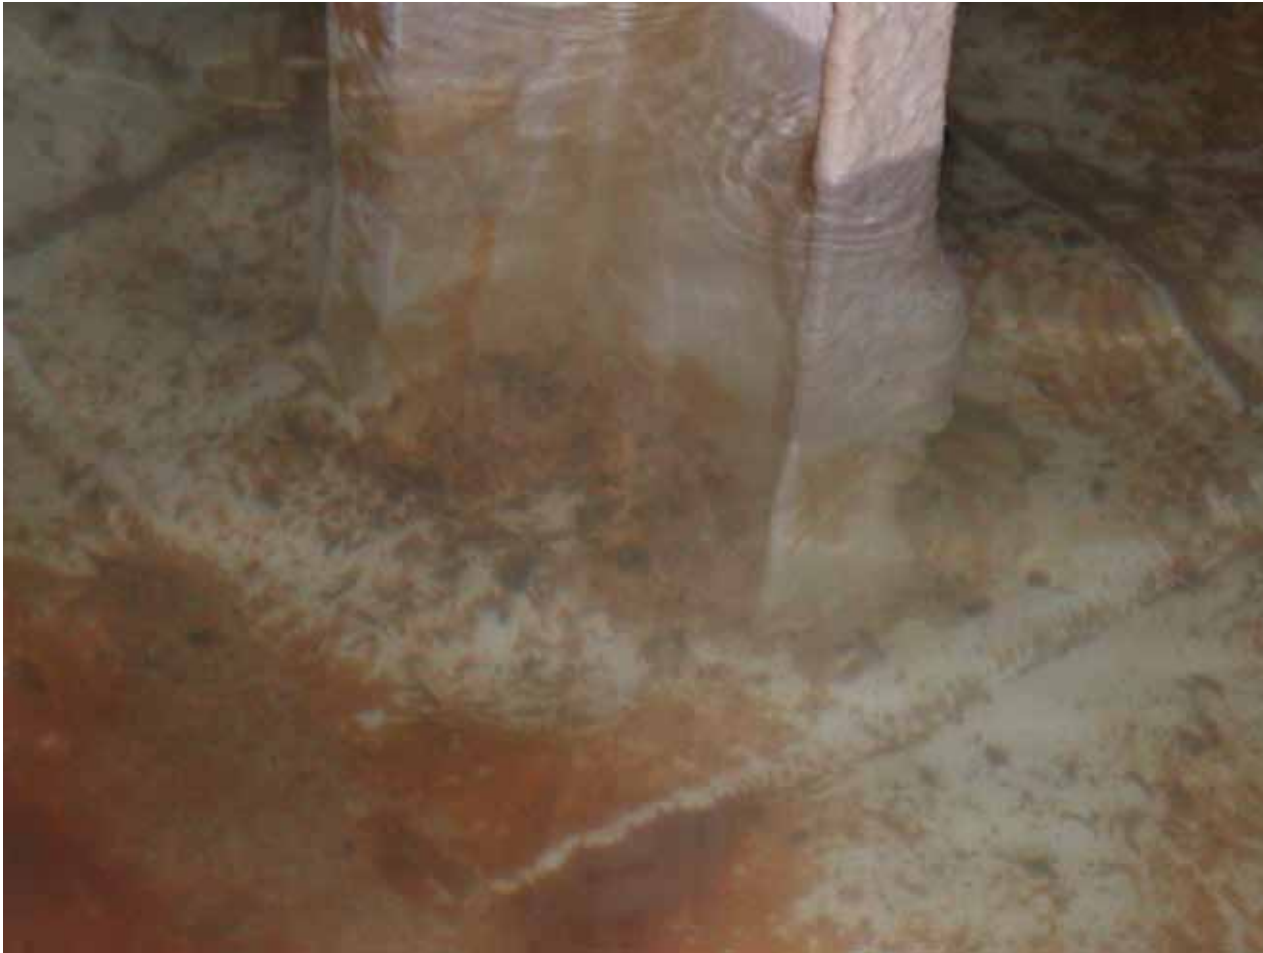
**Tank wouldn't drain properly because  
the valves were shot**

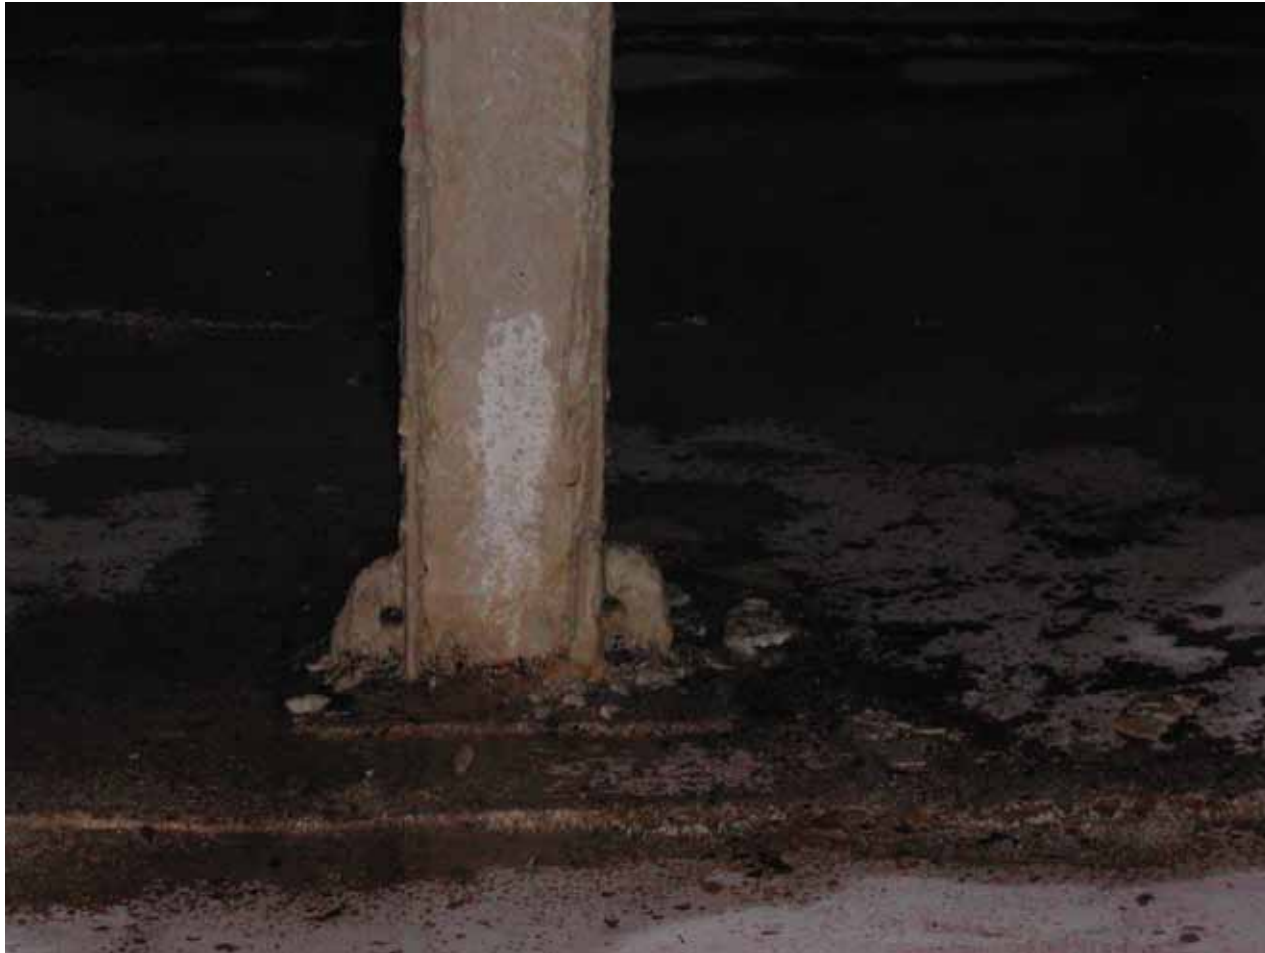
# Columns needed replacement

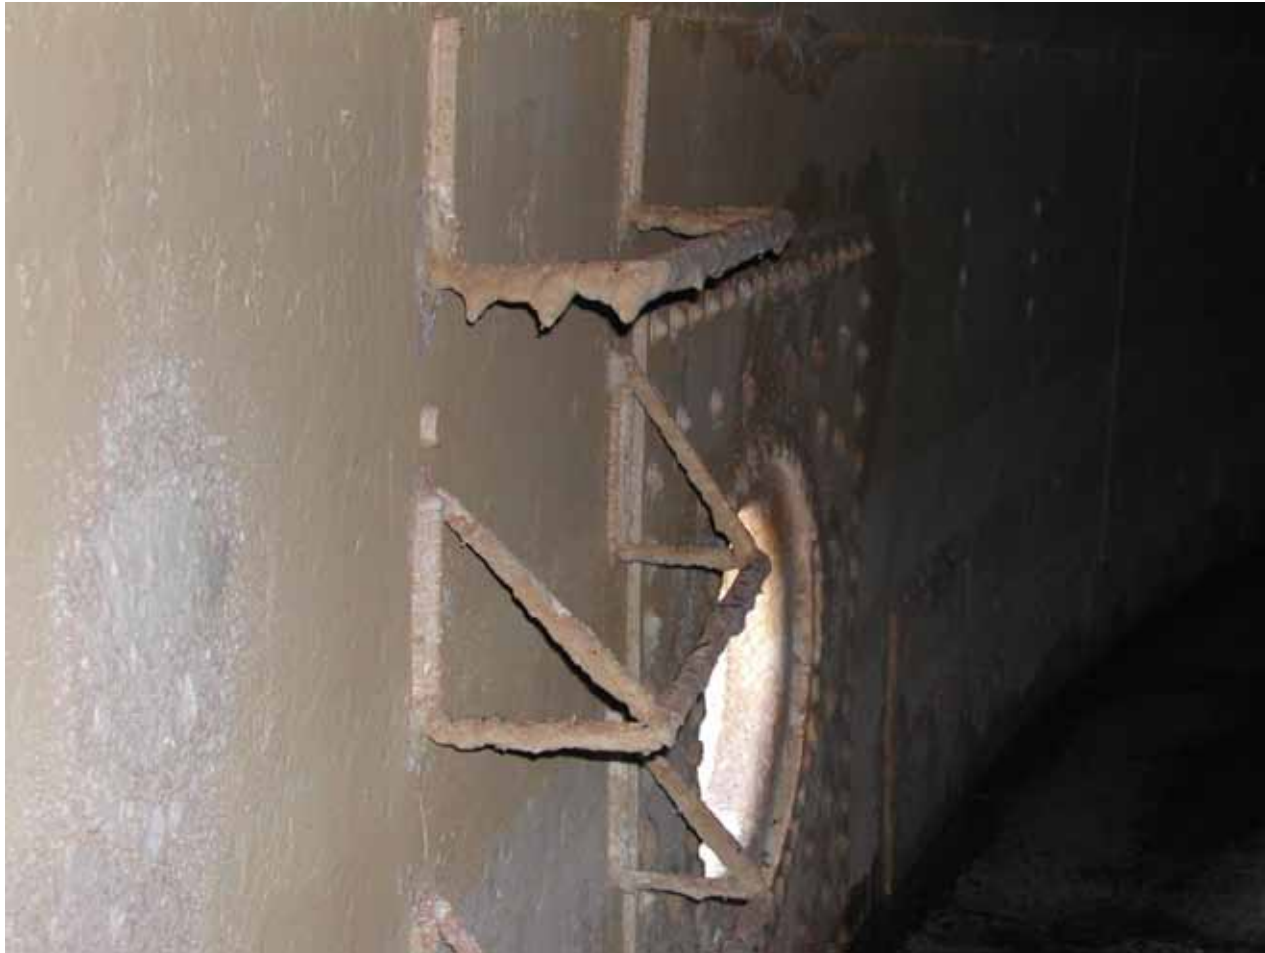
# Interior ladder needed to be removed

**We cut the old ladder out and ground the welds flush**
